# Study on Fuel Leakage Measurement System of Fuel Cell Vehicles

**Hiroyuki Mitsuishi, Yohsuke Tamura,  
Jinji Suzuki, Koichi Oshino, Shogo Watanabe**  
Japan Automobile Research Institute

Japan  
Paper Number 520

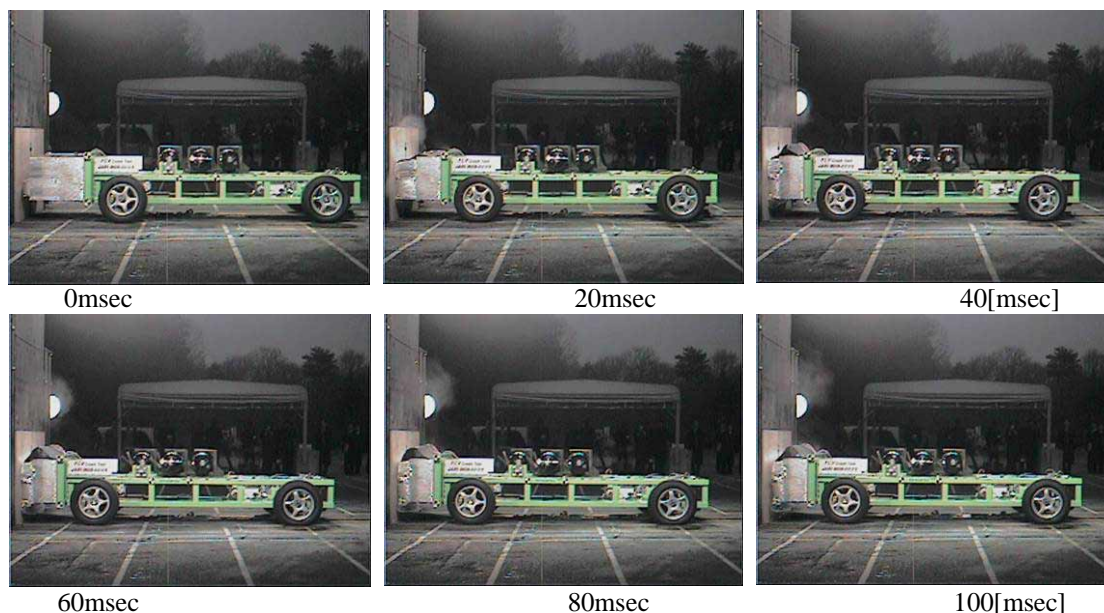
**Figure 6. Collision progress with high-speed video camera**

Figure 6 shows the collision progress with high-speed

( Safety factor for the cylinders from left side  
: 6.7, 26.7, 16.7 )

The total length of the honeycomb barrier material attached to the front section of the vehicle was 800 mm. The front portion of this was FMVSS214, and additional honeycomb barrier was attached at the rear to further increase strength. The test results showed that by 40 msec after the impact nearly the entire FMVSS214 portion of the front section had lost its shape, but there was little deformation of the rear honeycomb section added for this test. Further adjustment of strength is necessary.

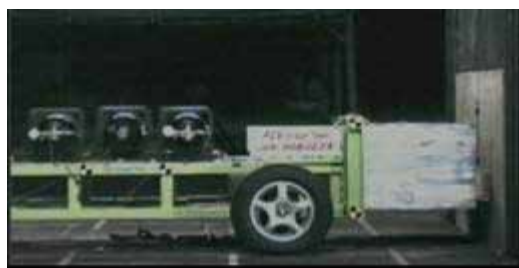
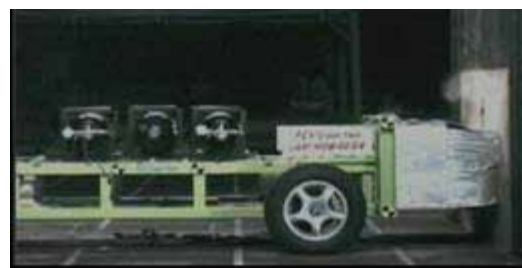
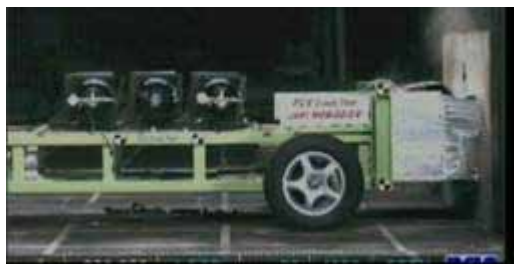
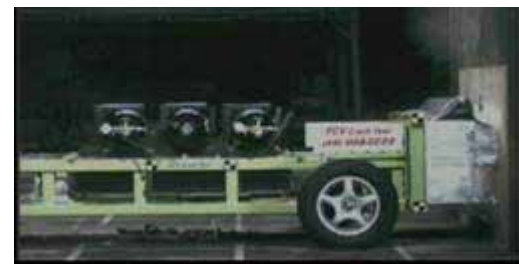
**Figure 10. Deformation start timings**

Next, considering tank attachment conditions, the photos in Fig. 10 show the time deformation starts during collisions with tank attachment fixtures of differing design strengths.

The fuel tank attachment support frameworks (beginning with upper left) had static safety rates set at 6.7, 26.7, and 16.7, respectively. Ten msec after the impact, deformation was seen in the fixture with a safety rate of 6.7. Deformations of the attachment support framework were seen 22 msec after impact with the 16.7 fixture, and at 42 msec with the 26.7 fixture. The deceleration at the time deformation could be determined was approximately 15 G, 40 G, and 27 G in the respective attachment support frameworks. No deformation was seen with each of the support frameworks, and the tanks remained fixed until deceleration reached 1.5 times the static safety rate.
